Full Scale Testing of Highway Bridge Rails and Median Barriers

Hveem, F.N. and J.L. Beaton

State of California
Department of Public Works
Division of Highways
Materials and Research Department
Sacramento, California

FULL SCALE TESTING OF HIGHWAY BRIDGE RAILS AND MEDIAN BARRIERS

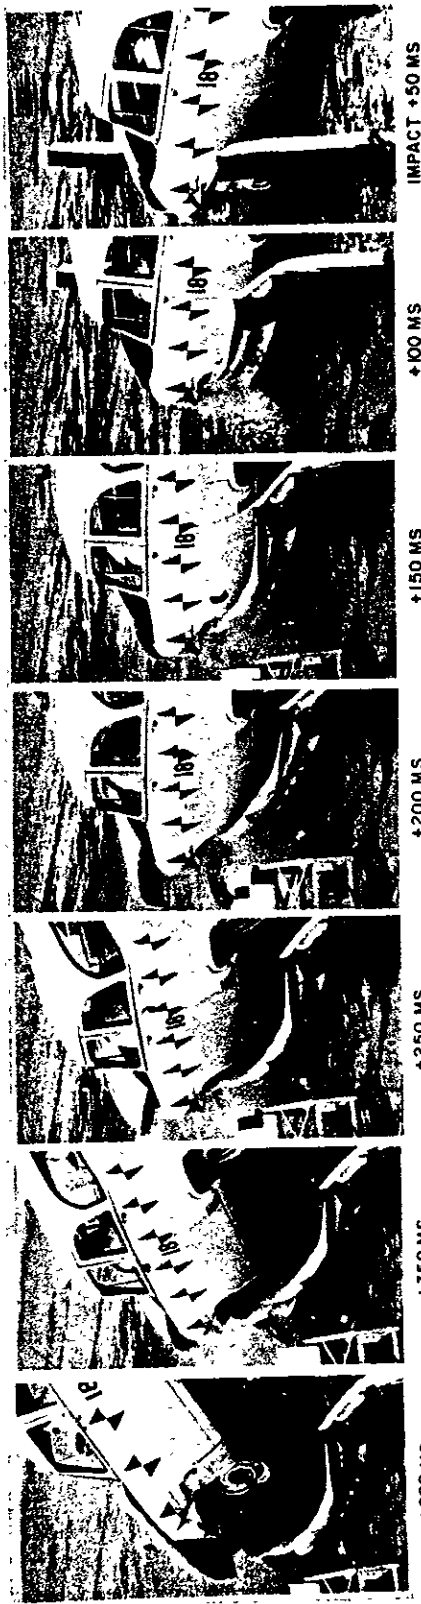
FIG. 5

BRIDGERAIL Single W Section
 BRACKET None
 POST 6" W 15.5 #
 POST SPACING 6'-3" O.C.
 LENGTH OF INSTALLATION . 62.5'
 GROUND CONDITION Wet
 PAVEMENT CONDITION Dimp

DUMMY INJURY Possible head & shoulder injuries.
 BRIDGERAIL DAMAGE 3 Sections damaged beyond repair.
 POST DAMAGE 5 Posts damaged beyond repair.
 VEHICLE DAMAGE Beyond economic repair.
 MAX. DYNAMIC DEFLECTION OF RAIL . . 60"
 TIME FROM IMPACT TO STOP 1050 milliseconds.

TEST NO. 18
 DATE 2-11-59
 VEHICLE Ford 92 Sedan
 SPEED 55 MPH
 IMPACT ANGLE 30°
 VEHICLE WEIGHT . . 4000
 (W/ DUMMY & INSTRUMENTATION)

When the dummy experienced excessive longitudinal decelerations, such as in Test No. 18 (Fig. 5), the dummy was thrown forward and the the left, striking the chest violently against the steering wheel and column, the skull impacting the header area. This action was typical of all tests where the front wheel assembly was trapped by the posts. A detailed analysis of steering wheel deformation with related injuries was not attempted due to the resistance offered the steering wheel by the remote steering pulley bracket.

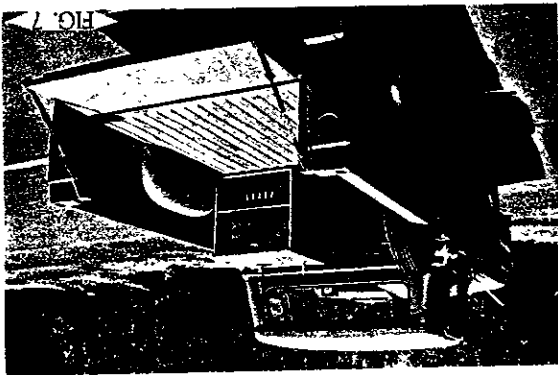
CONTROL TRUCK RADIO TRANSMITTING EQUIPMENT

Radio control of the vehicle along the 2,000 ft collision path was accomplished by means of 3 modulated tones and the R.F. carrier from a crystal controlled transmitter on 27.255 megacycles (citizens band) installed in the control truck (see Fig. 7).
